## Chagall Mosaic, "Les Quatre Saisons"

Condition Assessment and Repair Documents | Chicago, IL

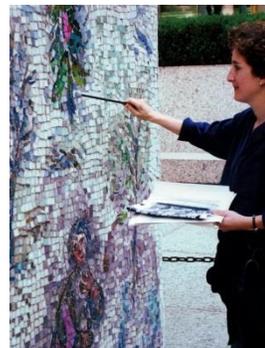
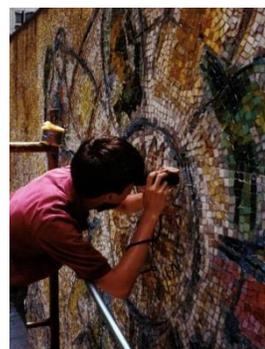
WJE performed a conservation assessment of the mosaic to detect areas of distress. Conditions were documented on photographic survey sheets, the inspection revealed light atmospheric soiling and other deposits, isolated instances of graffiti, loose or missing tesserae, cracking, and mismatched grout from previous conservation campaigns. Additionally, the bird deterrent system located on top of the mosaic was found to no longer be effective.

WJE removed the graffiti and cleaned the mosaic with a neutral pH, nonionic surfactant. Missing or damaged tesserae was replaced with new tesserae selected to best match the original shape and color. Where the bird deterrent system had detached from the granite copings, the posts were reattached with an adhesive.
