PROJECT PROFILE

First Stamford Place

Plaza Repairs | Stamford, CT

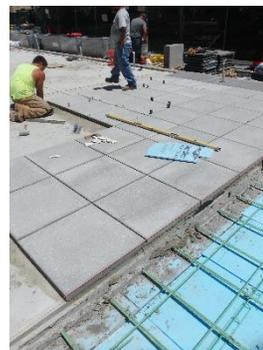
The concrete pavers at the entrance plazas to 100, 200, and 300 First Stamford Place were deteriorated with multiple areas of cracked or displaced pavers. While the underside of the concrete slab below the pavers did not display significant evidence of deterioration, building maintenance staff reported water leakage at expansion joints and other isolated locations below the plaza. Due to the ongoing water leakage, it was considered likely that there may be concrete deterioration on the top surface of the underlying structural slab.

WJE conducted an investigation to assess the condition of the existing waterproofing membrane and document concealed construction at the 200 First Stamford Place entrance plaza. WJE designed repairs that included replacement of the concealed waterproofing system; repair of the underlying structural slab; and replacement of the rigid insulation fill, concrete topping slab, and mortar-set concrete pavers at the 200 First Stamford Place entrance plaza.
